INFLUENCE OF NAIL LOCATIONS ON WIND RESISTANCE OF UNSEALED ASPHALT SHINGLES

THOMAS L. SMITH, AIA, RRC

MATT MILLEN

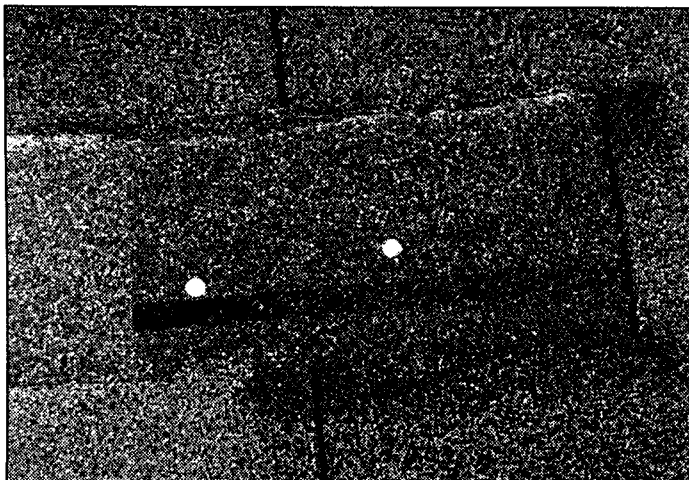
The influence of substantially offset fasteners on the wind performance of sealed shingles is not documented in the literature. However, as illustrated by Photo 1, it is likely that relatively large offsets are not problematic as long as the tabs remain sealed.

Photo 1. This roof lost a few tabs during a storm. These fasteners were substantially offset from the specified locations. However, tab blow-off was related to inadequate bonding of the sealant, rather than fastener location.

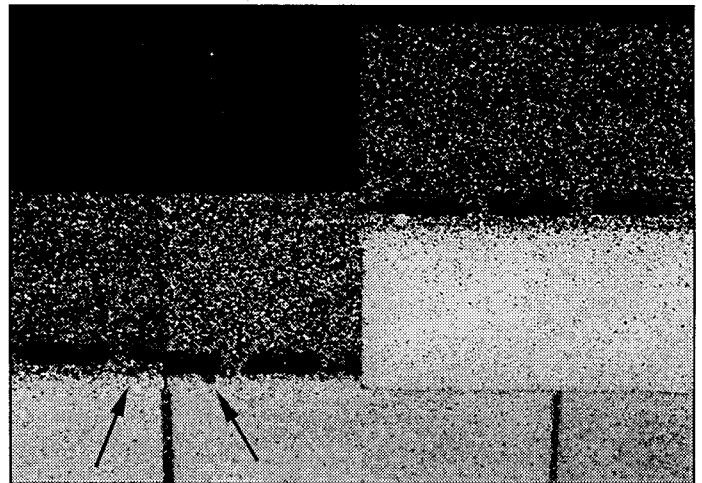
Photo 2. This roof is under construction. The end nail at the lower left corner was located as specified. However, the end fastener at the adjacent shingle was placed lower than specified in order to avoid placing the nail in the sealant (the sealant strip is lower on this shingle).

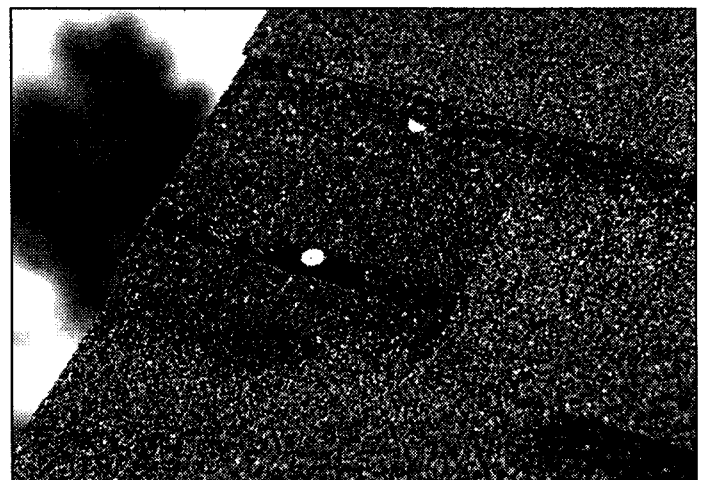
Photo 3. This roof lost a rake tab during a storm. Because the shingle extended past the edge of the deck, the nail was located inward of the typical location for end fasteners.

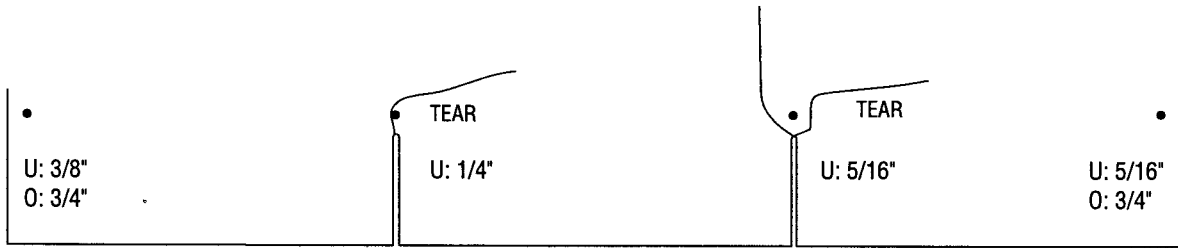
B1 E1 35° RUN 79 DAMAGE INDEX: 52

B1E3 had two small tears at the cutouts, whereas B1E1 had large tears at the cutouts. Although the damage was quite different, the nails above the cutouts in each of these runs were almost identically located. Each run had one nail that was $\frac{3}{8}$ inch (9.5 mm) below the specified location. B1E2 had one nail that was $\frac{1}{8}$ inch (3.2 mm) below the specified location, yet it, too, had a large tear at the cutout.

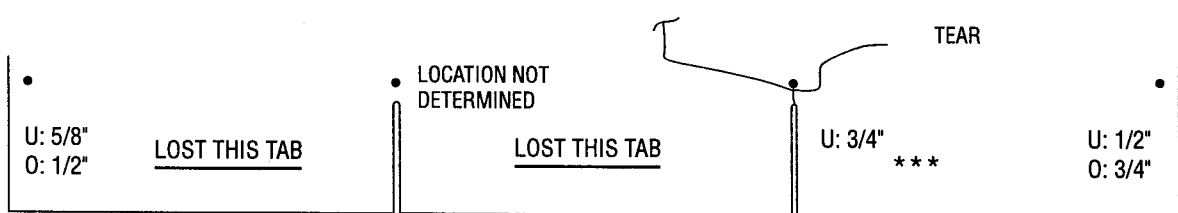
B1 G3 35° RUN 87 DAMAGE INDEX: 62

Although the greatest distance from the specified location occurred with end fasteners, tears only occurred at four end fasteners (decks B1A3, B1G3, B1G4 [tab blew off] and B2C7). A severe crack also occurred at one end fastener (B1A1). Hence, while only 5 percent of the shingles had damage at their ends, 68 percent of the end nails were greater than ¼ inch (3.2 mm) from their specified location.⁵

B1G3, which was in the same replicate set as the B1E runs, had one nail at a cutout that was $\frac{1}{16}$ inch (1.6 mm) below the specified location. At the other cutout, the nail was $\frac{1}{8}$ inch (3.2 mm) below the specified location. Although these nails were more accurately located than those at B1E1, B1E2 and B1E3, the tab was blown off between the cutouts and there were large tears extending from each cutout of B1G3.
